COST COMPARISON

FIP SILLCOCK with THREADED NIPPLE

PDQ™ PUSH SILLCOCK with PEX STUBOUT

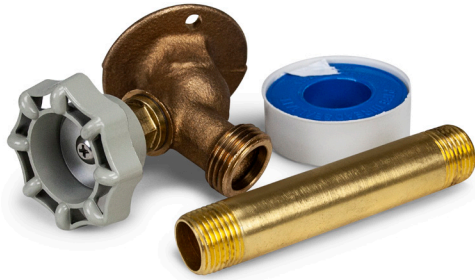
- Broken drop-ear elbow from overtightening causing leaks in basement or at sillcock.
- Untested joints/mechanical joints behind wall
- Added bracketing for drop-ear elbow
- Various nipple lengths needed
- Proper valve outlet orientation when tightening
- Leaded materials

Steps		Input Time in Minutes
Rough	Install bracketing	
	Secure drop-ear or sweat elbow	
	Install test nipple or cut/install stub out	
	Test	
Finish	Remove test nipple or cut stub out	
	Clean/cut/deburr or select nipple length	
	Prep for connection (flux/tape/etc.)	
	Connect sillcock in proper position	
	Test	
	Secure sillcock to wall	
Total Time

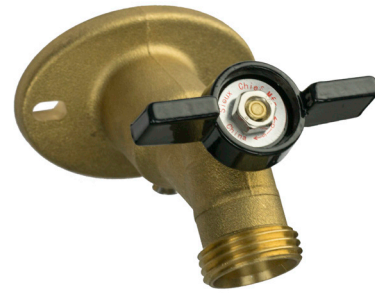
- Easiest sillcock to install, repair or replace
- **No Lead** material is DZR and SCC resistant
- Extended outlet - Easy hose connection
- ¼-Turn operation. Tee handle.
- Wide, secure base flange with fully enclosed mounting holes. Mounting flange hole template on Box
- Built-in removal tool - fits tight to CTS, inhibits water entering structure

Steps		Input Time in Minutes
Rough	(Optional) Install Square-O-Strap™ for stub out support	
	Cut & install PEX sleeve, plug and crimp ring	
	Cut end to length, remove sleeve & plug	
	Test	
Finish	Cut off plug/ring, remove sleeve, prep tube	
	Push on removal tool and sillcock	
	Test	
	Secure sillcock to wall	
Total Time
